# LEMHI COUNTY AIRPORT

This report describes how your pavement maintenance management program was developed. This program was developed as part of the Network Pavement Management Program project sponsored by the Idaho Transportation Department, Division of Aeronautics. The information and data contained in this report ensures you are in compliance with the requirements of Federal Aviation Administration (FAA) Grant Assurance Number 11 which states that any airport requesting federal funds for pavement improvement projects must have implemented a pavement maintenance management program (PMMP).

Using the branch, section and sample unit divisions established, a visual condition survey was conducted at Lemhi County Airport on October 31, 2006. During the inspection pavement defects were identified and measured in accordance with the methodology outlined in FAA AC:150/5380-6 and ASTM D5430. Our inspection ensures your airport complies with the “detailed inspection” requirement of FAA’s PMMP guidelines. After collection, the data were entered into the Micro PAVER software for analysis. These data are reproduced in the Re-Inspection Report attached in Appendix 2. Photographs of typical

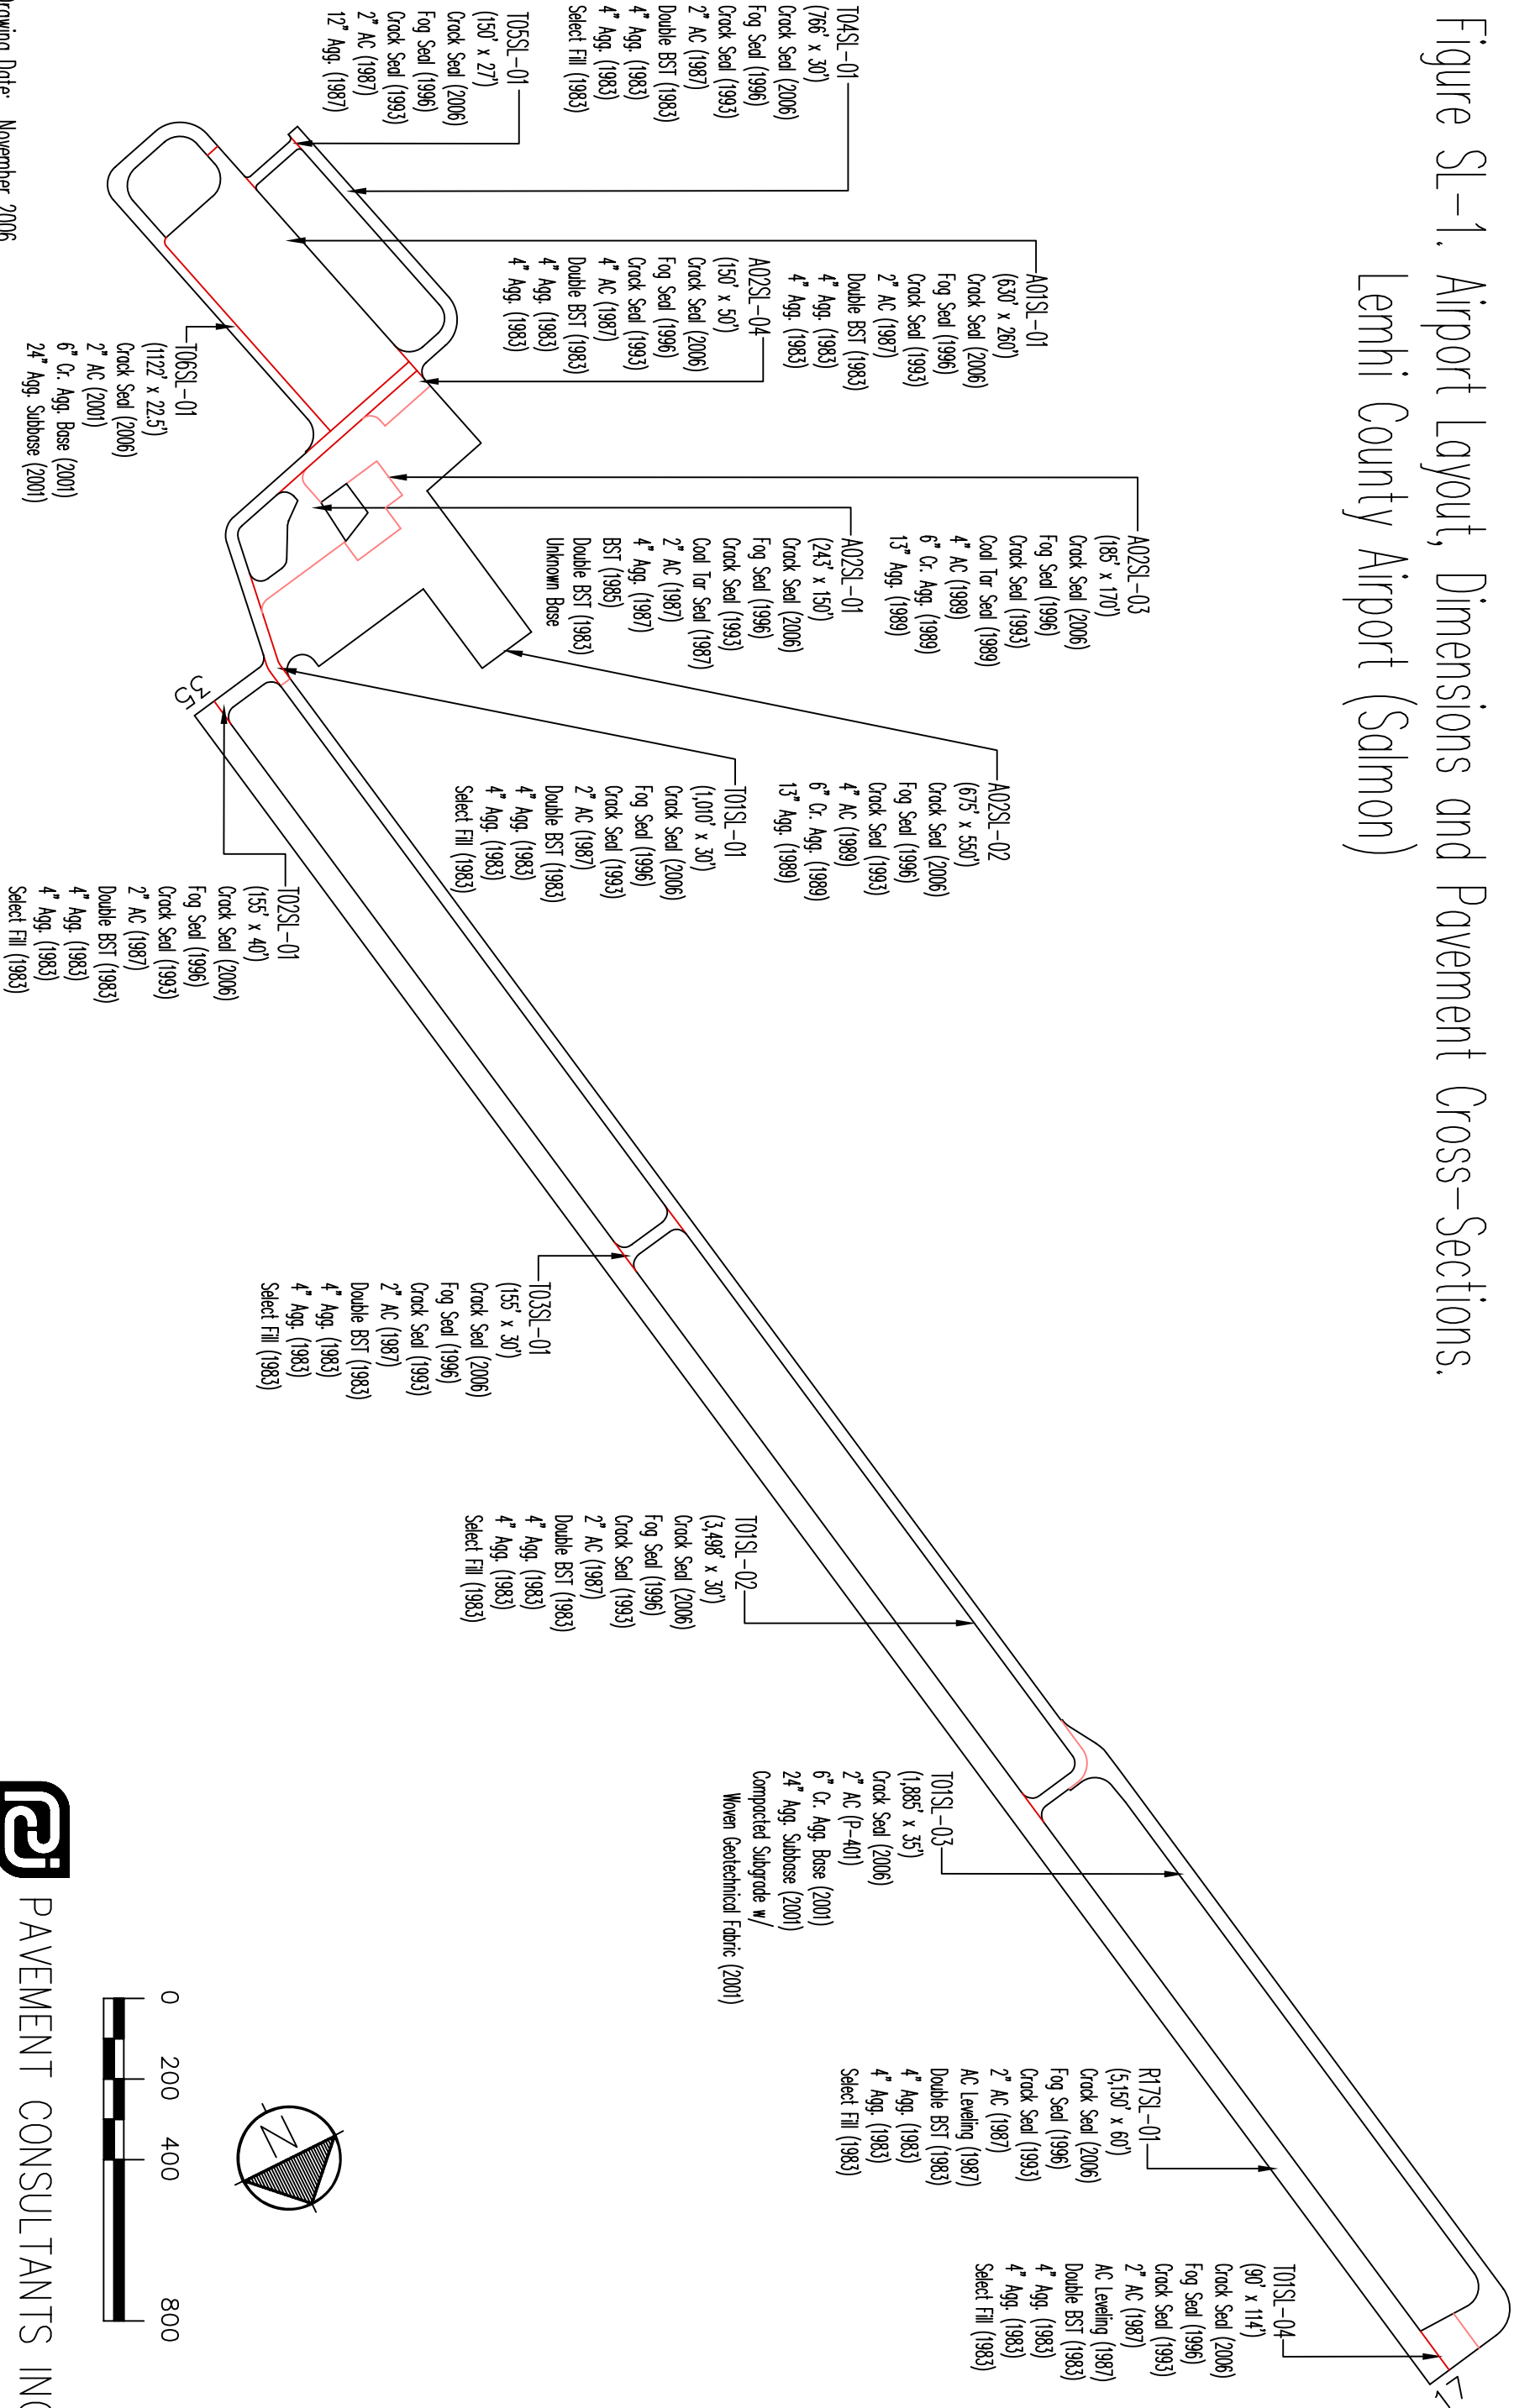
Figure SL-1. Airport Layout, Dimensions and Pavement Cross-Sections.  
Lemhi County Airport (Salmon)

To determine how your pavements were constructed and their age, a records review was conducted. Figure SL-1 shows the records review results. This figure shows pavement boundaries, dimensions, pavement layer types, thicknesses and dates of construction. Table SL-1, provided in Appendix 1, contains the up-to-date cross-section information for each pavement section. The most recent construction date for each pavement can also be found in the Section Condition Report in Appendix 2. Figure SL-1, Table SL-1, and the information contained in Appendices 1 and 2 ensure that your airport complies with the “pavement inventory” requirement of FAA’s PMMP guidelines.

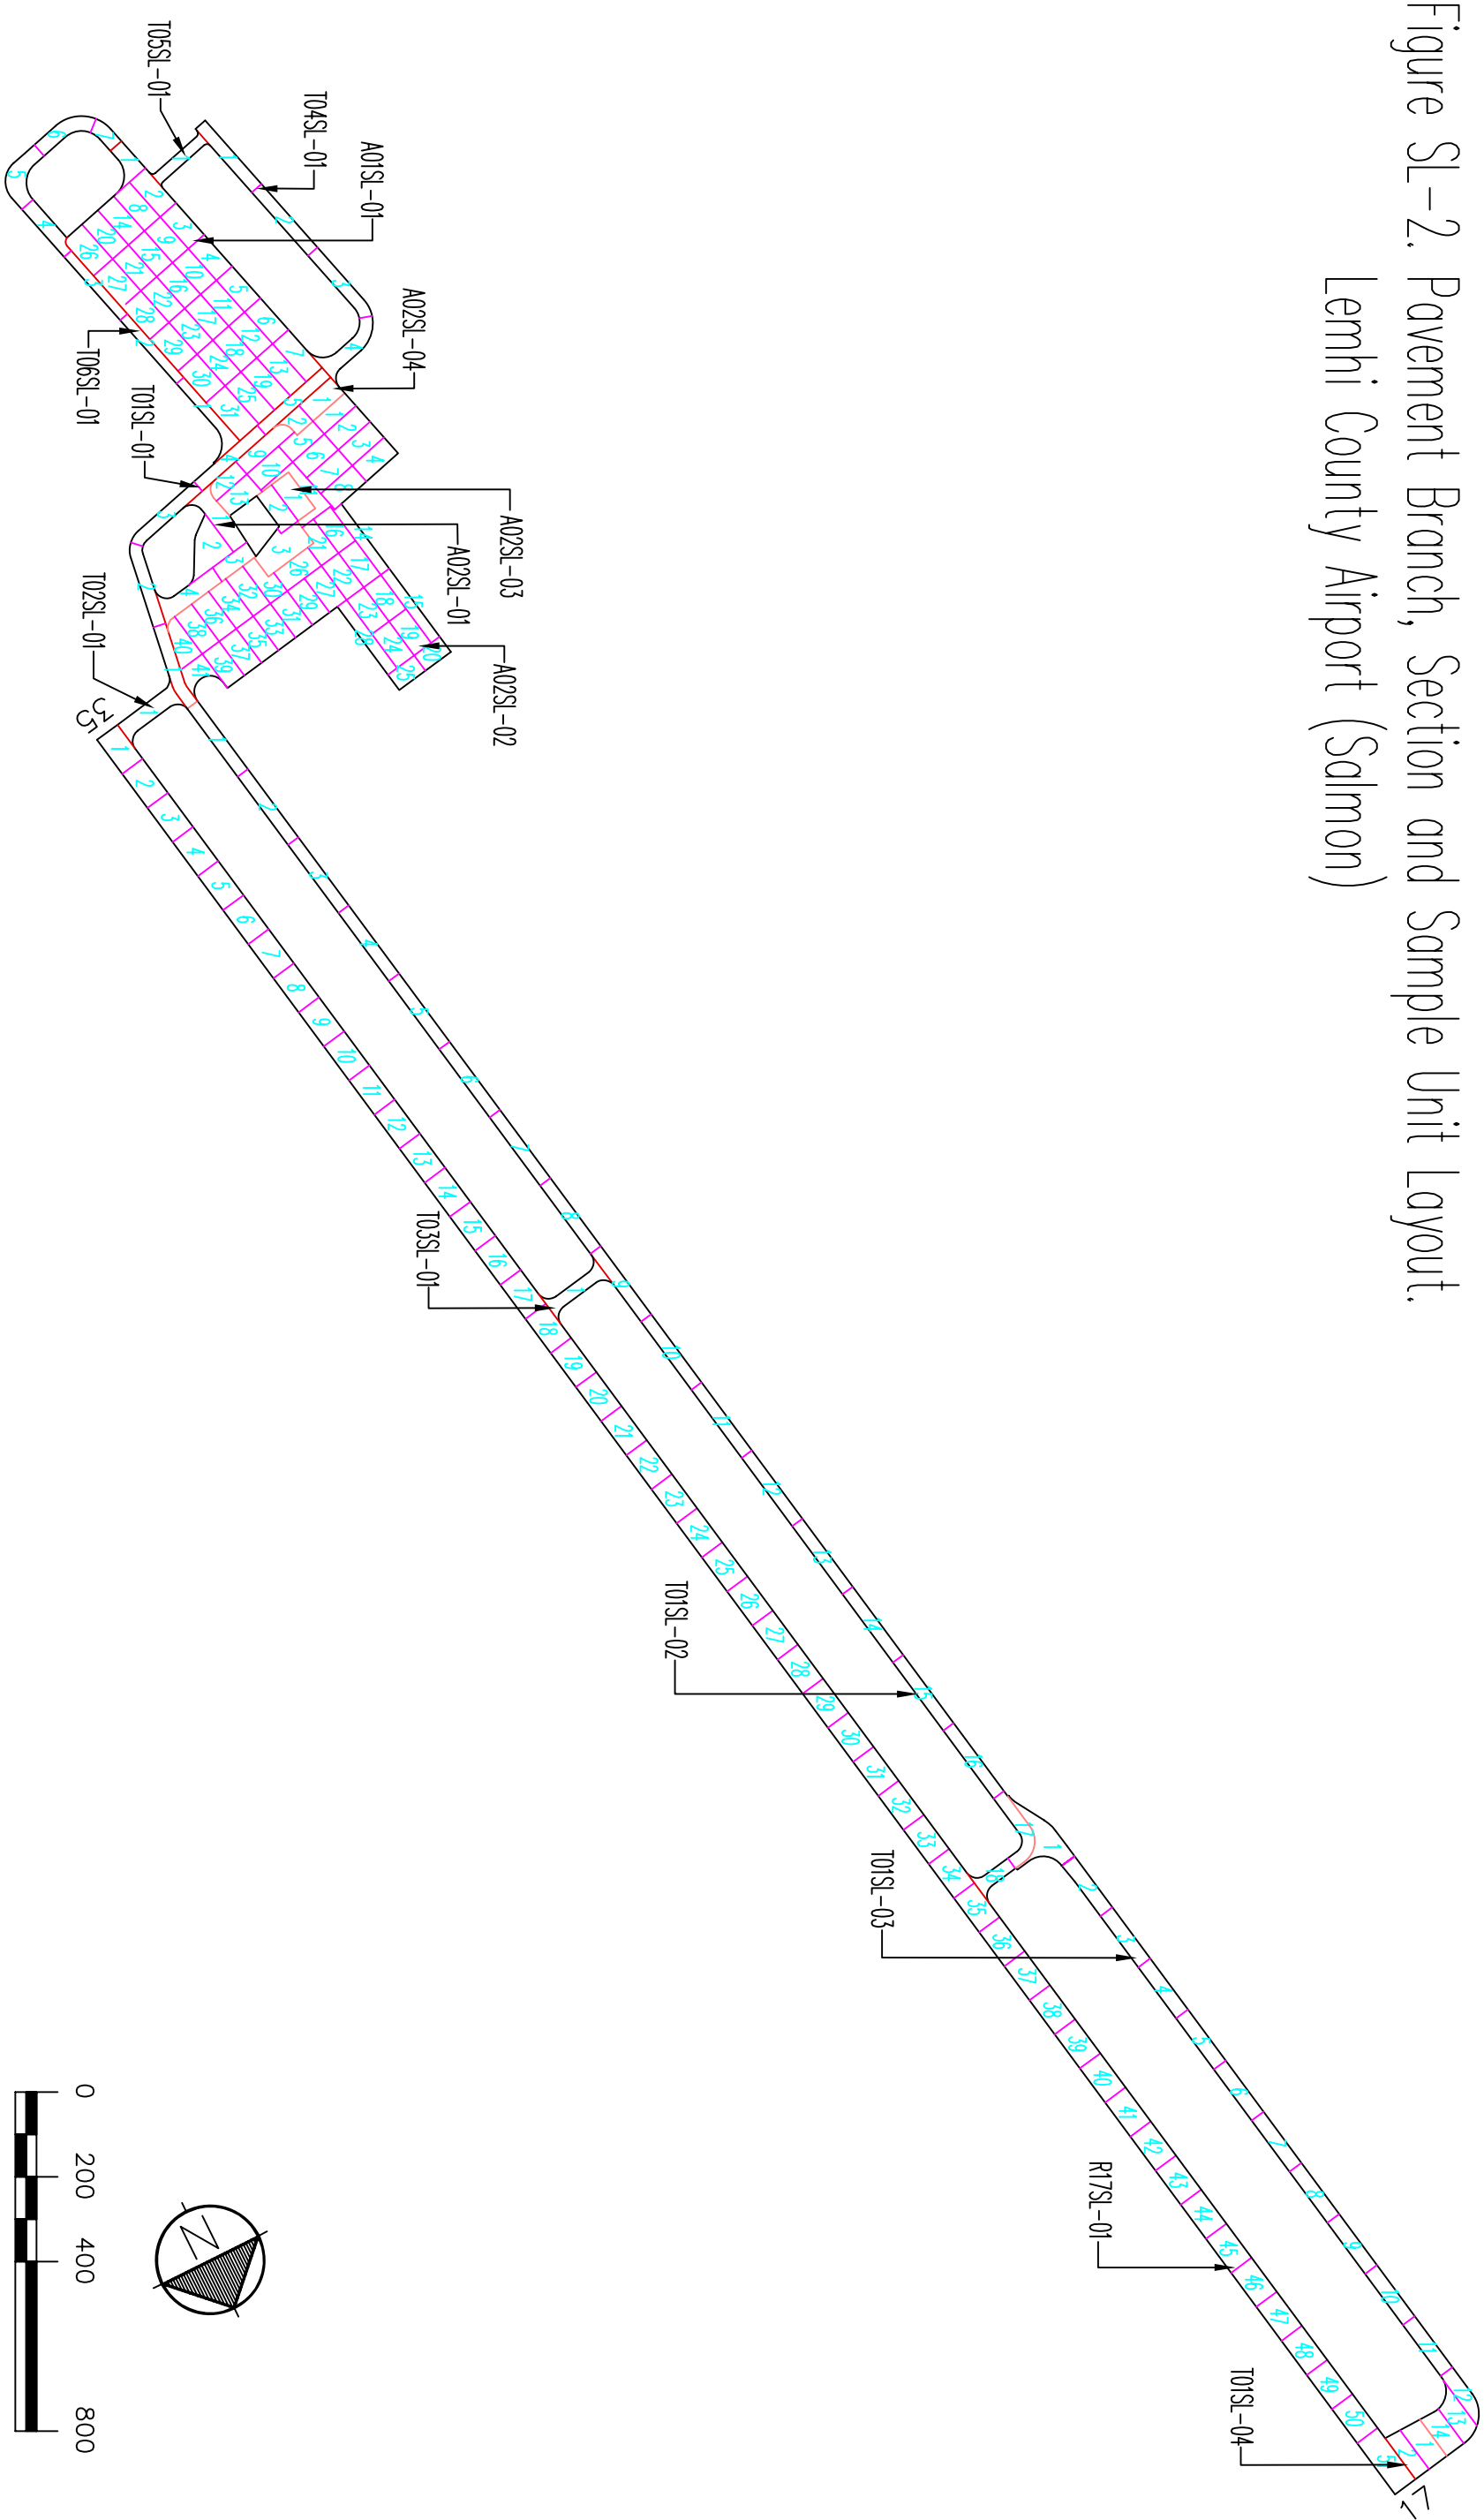
Figure SL-2. Pavement Branch, Section and Sample Unit Layout.  
Lemhi County Airport (Salmon)

The pavements at your airport were divided into branches, sections and sample units in accordance with the methodology outlined in the current editions of FAA Advisory Circular AC:150/5380-6, *Guidelines and Procedures for Maintenance of Airport Pavements* and ASTM D5430, *Standard Test Method for Airport Condition Index Surveys*. The branches, sections and sample units established at your airport are shown in Figure SL-2. A Branch Condition Report showing all branches, their associated areas, and area-weighted condition is provided in Appendix 2. Additionally, the Appendix 2 Section Condition Report provides information that the Micro PAVER pavement management software uses to define each branch and section.

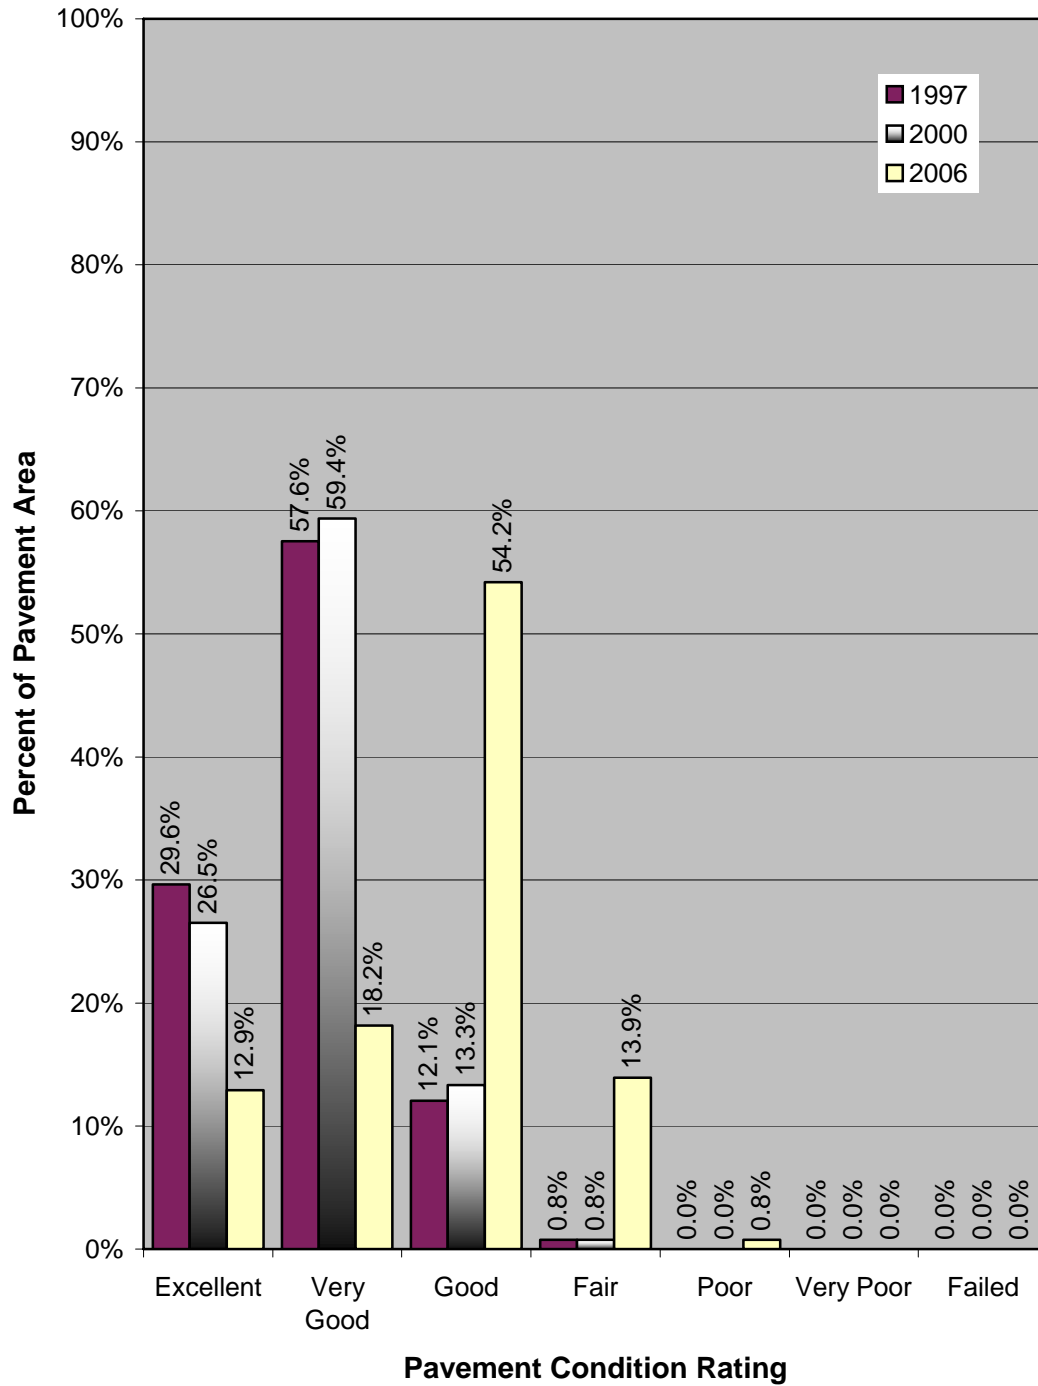
**Figure SL-4. Distribution of Pavement Condition  
Lemhi County Airport**

Section PCIs at the airport range from a low of 36 (a PCR of "Poor") to a high of 100 (a PCR of "Excellent"). The area-weighted average PCI for all airport pavements is 66, corresponding to an overall PCR of "Good". Figure SL-4 shows how much pavement area is associated with each Pavement Condition Rating category and also shows pavement condition distribution from the inspections conducted in 1997 and 2000. A graphical representation of the projected PCRs presented in Table SL-2 is shown in Figure SL-5.
